# **WATER DAMAGE/MOLD INVESTIGATION**

**Department of Children and Families  
143 Munson Street  
Greenfield, MA**

Prepared by:  
Massachusetts Department of Public Health  
Bureau of Environmental Health  
Indoor Air Quality Program  
December 2018

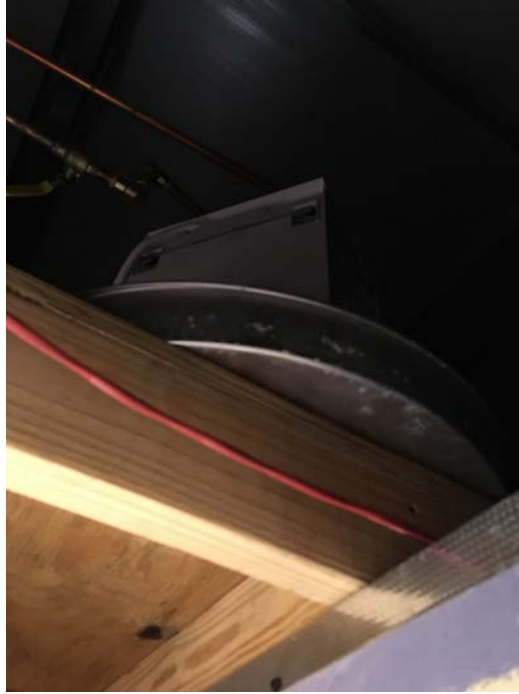
**Picture 1**

The BEH/IAQ Program was asked to examine the DCF building due to water damage from a combination of a water heater failure and high relative humidity during the hot, humid weather during the summer months of 2018. A water heater located above the wall cavity of the employee restroom (Picture 1) catastrophically failed in August 2018. Over time, a musty odor developed in the employee restroom. Upon entering the employee restroom, IAQ staff detected a distinct musty odor, but could not readily identify the source of the odor.

**Water heater inside ceiling plenum**
